# Ministry of Natural Resources, Energy and Mining

Department of Climate Change and Meteorological Services

## **FASH FLOODS IN MALAWI: Case studies for 2013, 2015, 2016 and 2017 seasons**

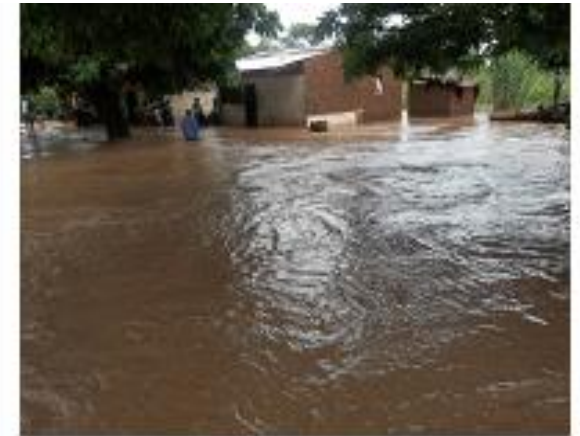
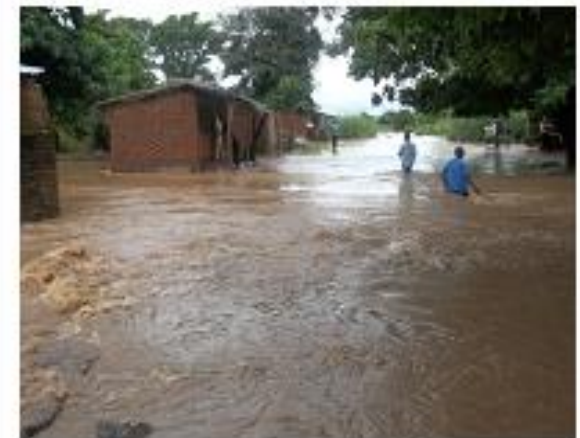
Figure.8: Floods due to North Rukuru River over flow on 11<sup>th</sup> January 2013

The System highlighted an alert for Flash floods in Rumphu and Karonga. Figure.4-6: Figure 8 shows the aftermath of the threat.

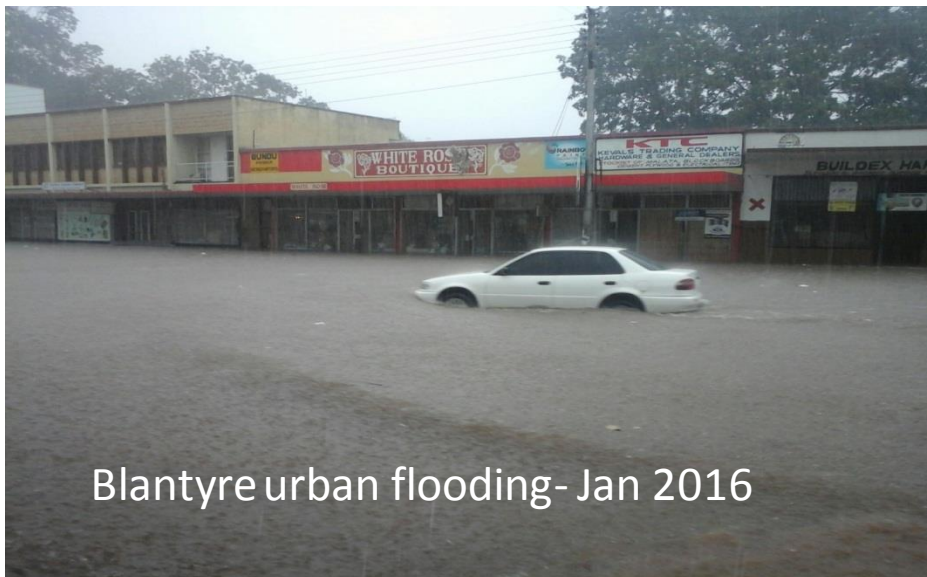
Blantyre urban flooding- Jan 2016

- The Blantyre Flooding was attributed to heavy precipitation and poor drainage system
- The Lilongwe flash floods were as a result of blockage of streams by constructions along and in the water-ways.

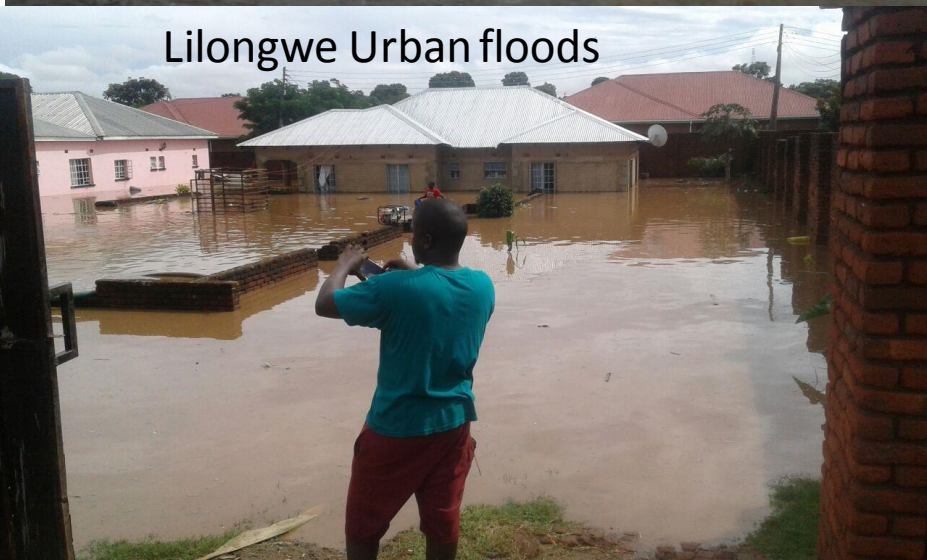
Lilongwe Urban floods
