**THE NEW ORLEANS
HURRICANE PROTECTION SYSTEM:**
What Went Wrong and Why

**A Report by the American Society of Civil Engineers
Hurricane Katrina External Review Panel**

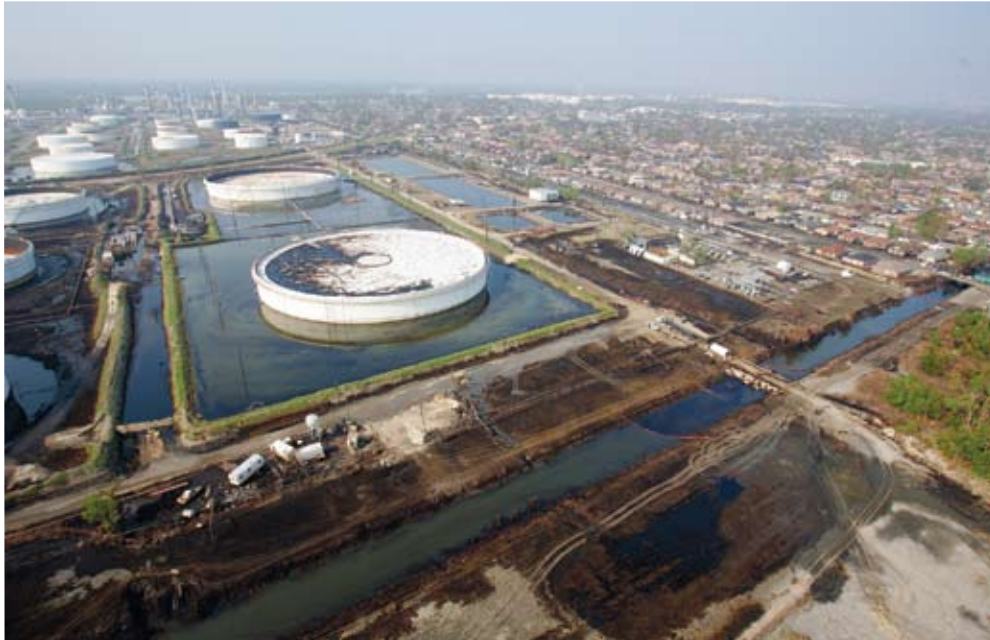
Figure 2.2 Flooded Petroleum Storage Tank Farm

New Orleans is a major hub of regional petroleum production and refining operations providing up to 30 percent of the nation's oil. Damage to the petroleum complex from Hurricane Katrina was extensive.

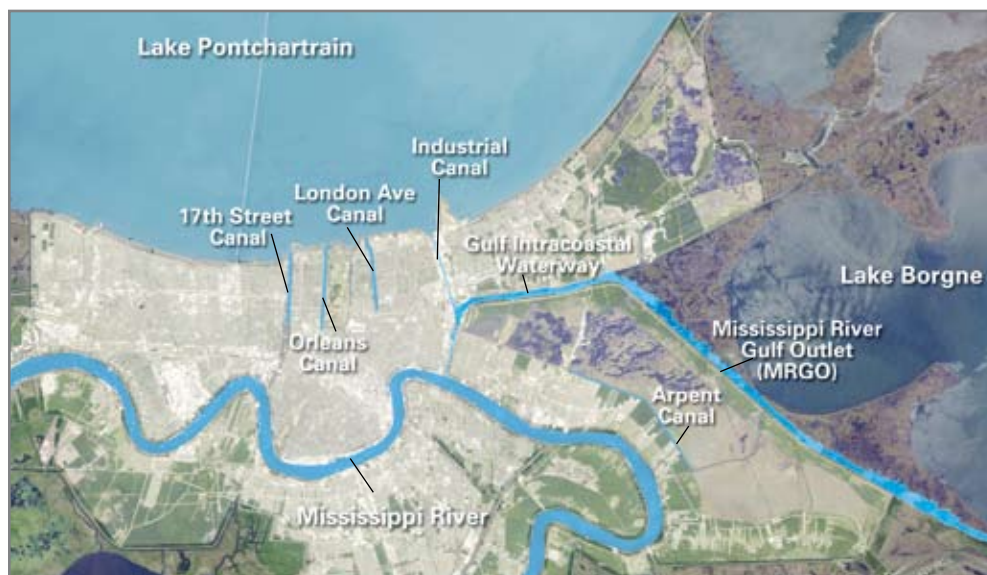
Figure 2.5 The New Orleans Waterways

New Orleans is surrounded by – and inter-fingered with – water: lakes, rivers, bayous, and canals.

Levees and floodwalls were also built on the banks of several of the former bayous from Lake Pontchartrain into New Orleans. Waterways of significance to this report (as shown in [Figure 2.5](#)) include:

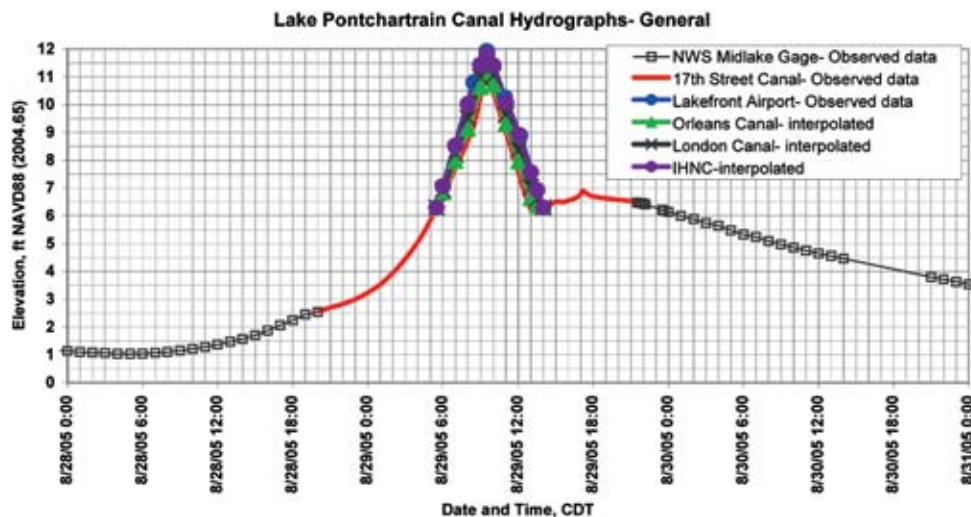
Figure 3.5 Hydrograph for the Canal Entrances at Lake Pontchartrain

On the lakeshore of New Orleans, water levels from the storm surge built up to a peak at 9:30am. By 10:00am, the eye of the hurricane had passed slightly to the northeast of New Orleans, and the water levels began to fall.

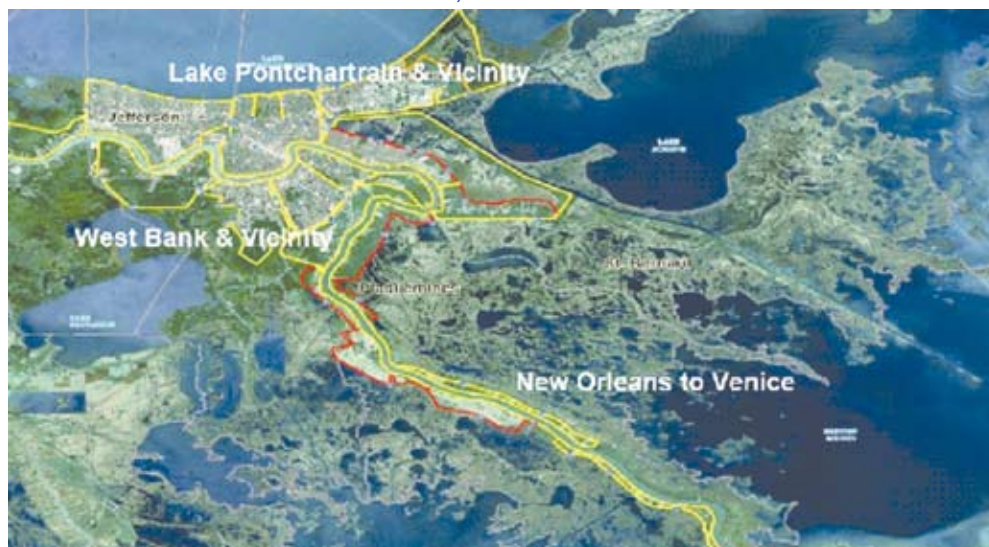
Figure 4.1 Three USACE Hurricane Protection Systems in Southeast Louisiana

Over the past several decades, the USACE has designed and built three main hurricane protection systems to protect New Orleans and surrounding parishes from hurricane-induced flooding. The USACE designed and built the majority of the levees and floodwalls but they are maintained by local levee boards. Other levees and floodwalls are owned and operated by local levee boards. All of the pump stations are owned and operated by local agencies.

The USACE's overall strategy to protect against flooding caused by hurricanes and storm surge was to build levees or floodwalls around segments of New Orleans. The USACE projects are generally grouped into three main units, as shown in *Figure 4.1*:

- Lake Pontchartrain, Louisiana and Vicinity Hurricane Protection Project
- West Bank and Vicinity, New Orleans, Louisiana, Hurricane Protection Project
- New Orleans to Venice, Louisiana, Hurricane Protection Project

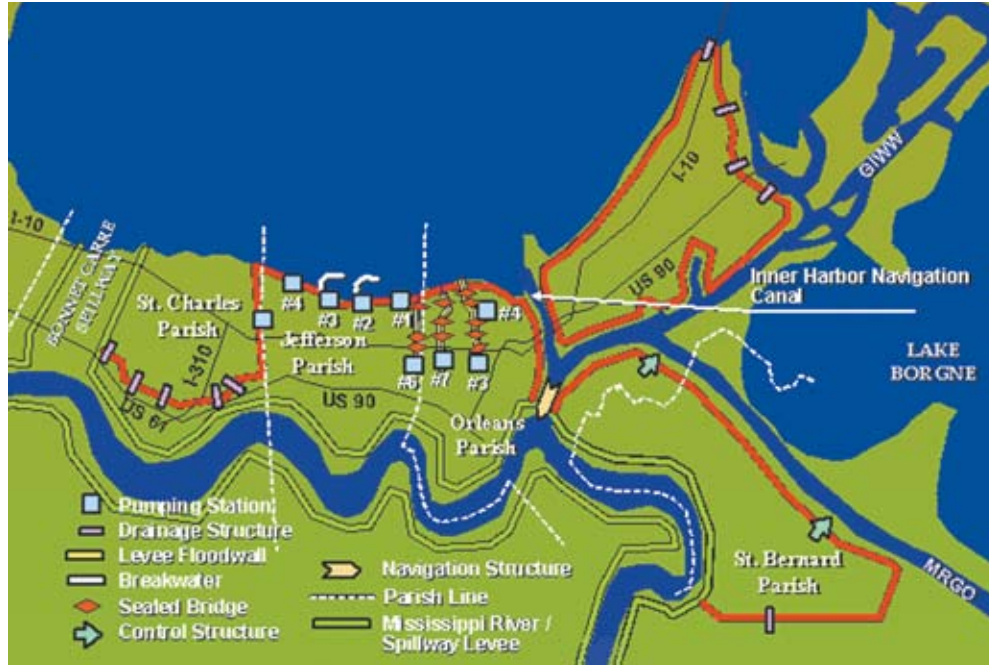
Figure 4.2 Lake Pontchartrain, Louisiana and Vicinity Hurricane Protection Project

Failures within this hurricane protection system, comprised of earthen levees and floodwalls, caused the majority of the widespread flooding and damage during and after Hurricane Katrina.

The Lake Pontchartrain, Louisiana and Vicinity Hurricane Protection Project (*Figure 4.2*) was intended to protect St. Bernard, Orleans, Jefferson, and St. Charles parishes between the Mississippi River and Lake Pontchartrain. The project generally included earthen levees with floodwalls along Lake Pontchartrain, the 17th Street Canal, the Orleans Canal, the London Avenue Canal, and the Industrial Canal.

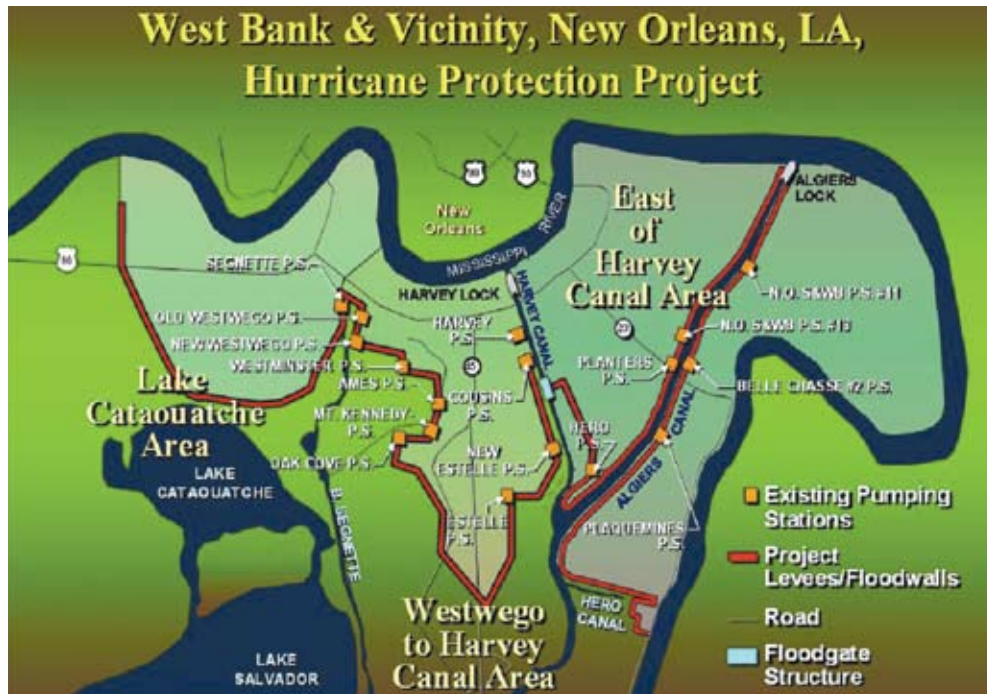
Figure 4.3 West Bank and Vicinity, New Orleans, Louisiana, Hurricane Protection System

This hurricane protection system consists of earthen levees and floodwalls in New Orleans on the west bank of the Mississippi River.

The West Bank and Vicinity, New Orleans, Louisiana, Hurricane Protection System (*Figure 4.3*) was intended to provide improved hurricane protection and flood control to portions of Jefferson Parish lying between the Mississippi River and Lake Salvador. The recommended plan included 22 miles of earthen levees and 2 miles of floodwalls extending from the canal to the V-levee near Jean Lafitte National Historical Park back north to the town of Westwego.

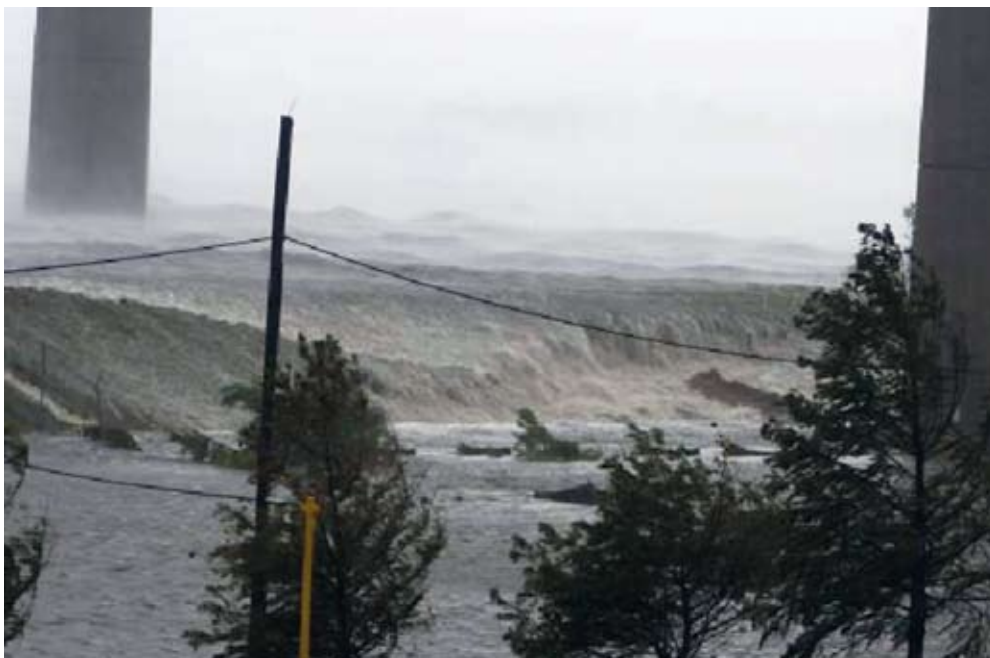
Entergy Corporation personnel took this photo of storm surge waters cascading over a levee near the Entergy power plant in the New Orleans East area.

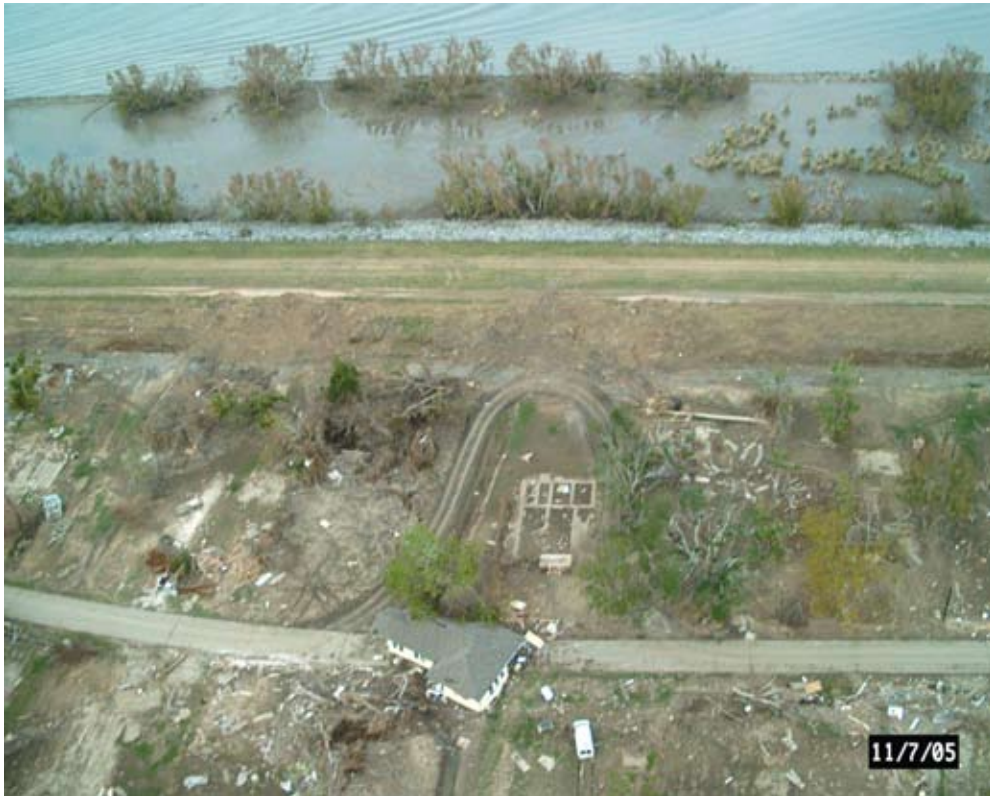
The storm surge from Hurricane Katrina overtopped levees (seen in this photo adjacent to the water) in Plaquemines Parish and knocked hundreds of homes off their foundations. (This photo was taken after flood waters had receded.)

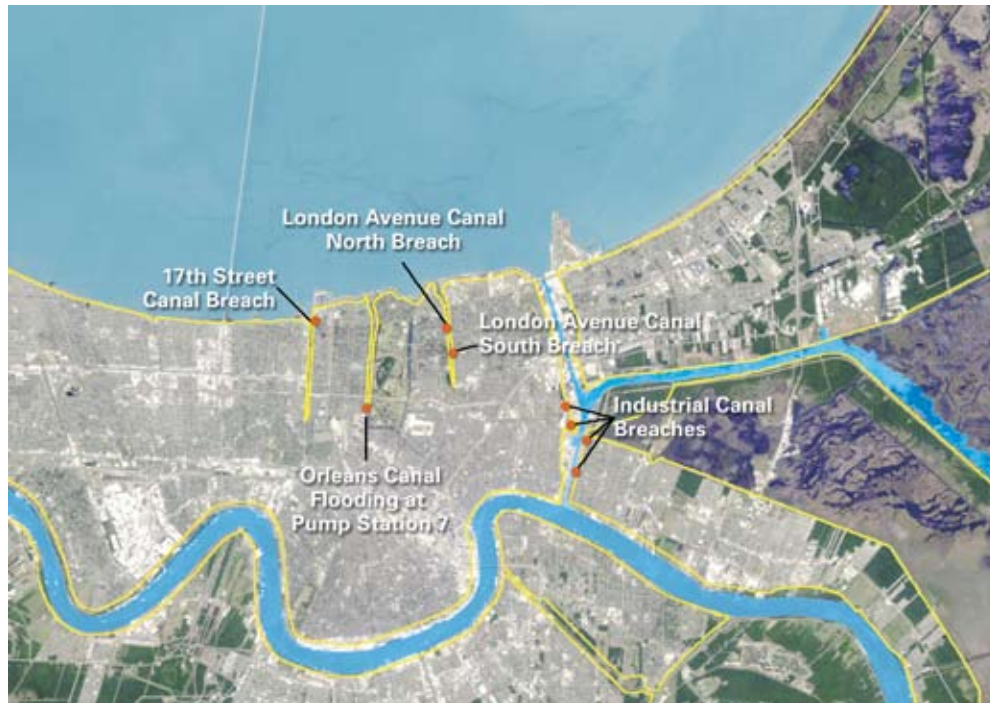
Figure 5.3 Major Breaches in the New Orleans Hurricane Protection System

Failures of several I-walls and levees along the canals that finger into New Orleans allowed massive amounts of water to flood New Orleans.

Before and during Hurricane Katrina's landfall, ruptures (or breaches) in four I-walls developed (*Figure 5.3*)—all before water levels in the adjacent canals overtopped them .

At about 5am, a breach in the east bank of the Industrial Canal I-wall contributed the first flow of floodwaters to the Lower Ninth Ward in St. Bernard Parish. At about 6:30am, a breach was observed in the I-wall on the Orleans Parish side of the 17th Street Canal, which flooded a portion of Lakeview.

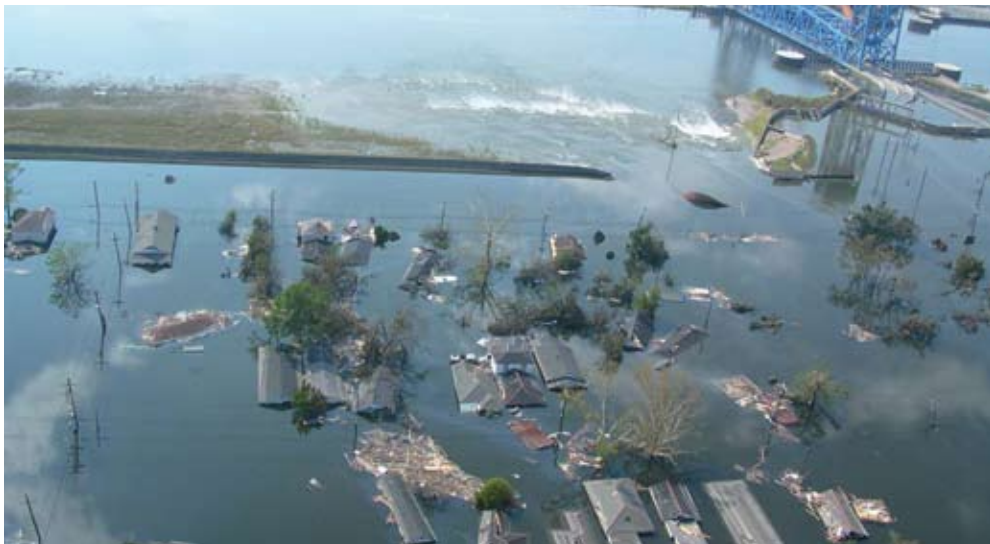
Floodwater from the Industrial Canal (top) rushed through a breach in the east bank I-wall into the Lower Ninth Ward (bottom). Water from the Industrial Canal also flowed into the Upper Ninth Ward, Bywater, and Tremé neighborhoods from breaches on the west side of the canal. (This photo was taken after floodwaters began to recede and water flowed from the Lower Ninth Ward back into the Industrial Canal.)

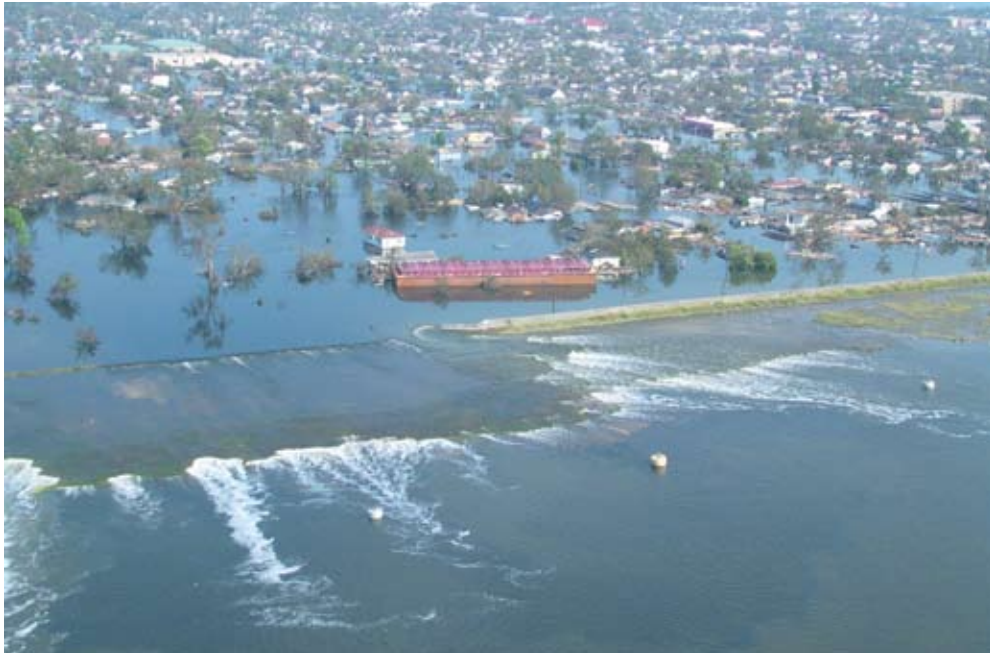
Water cascading over the floodwall at this location scoured out the wall's support and caused the breach. Waters from the Industrial Canal (bottom) rushed into the Lower Ninth Ward (top) with great force. (This photo was taken after the floodwaters began to recede and water flowed from the Lower Ninth Ward back into the Industrial Canal.)

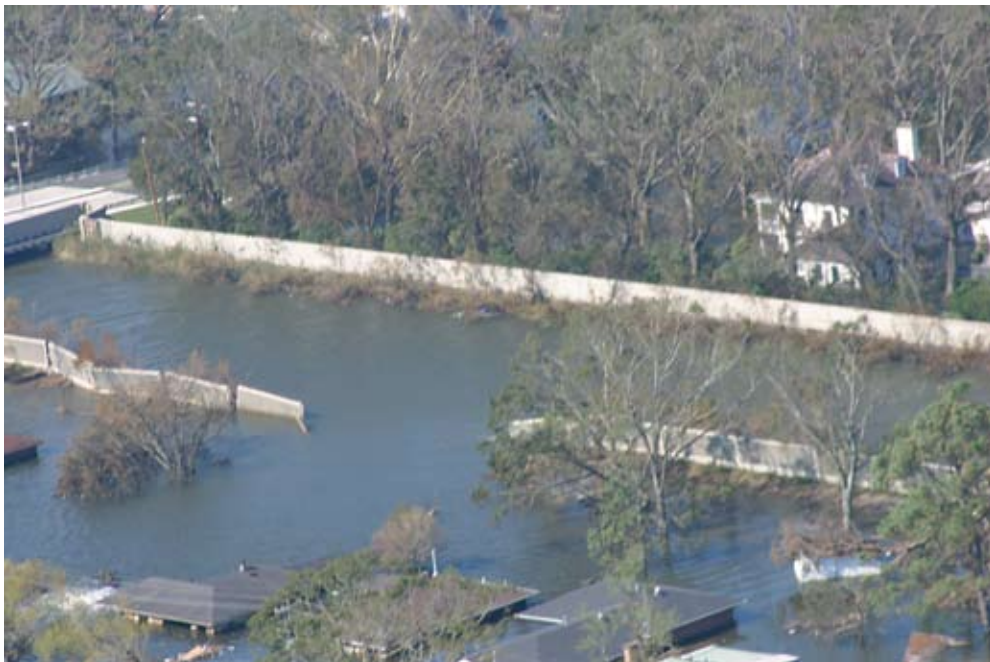
An I-wall failure on the east side of the London Avenue Canal allowed water to spill into the Gentilly neighborhood of New Orleans.

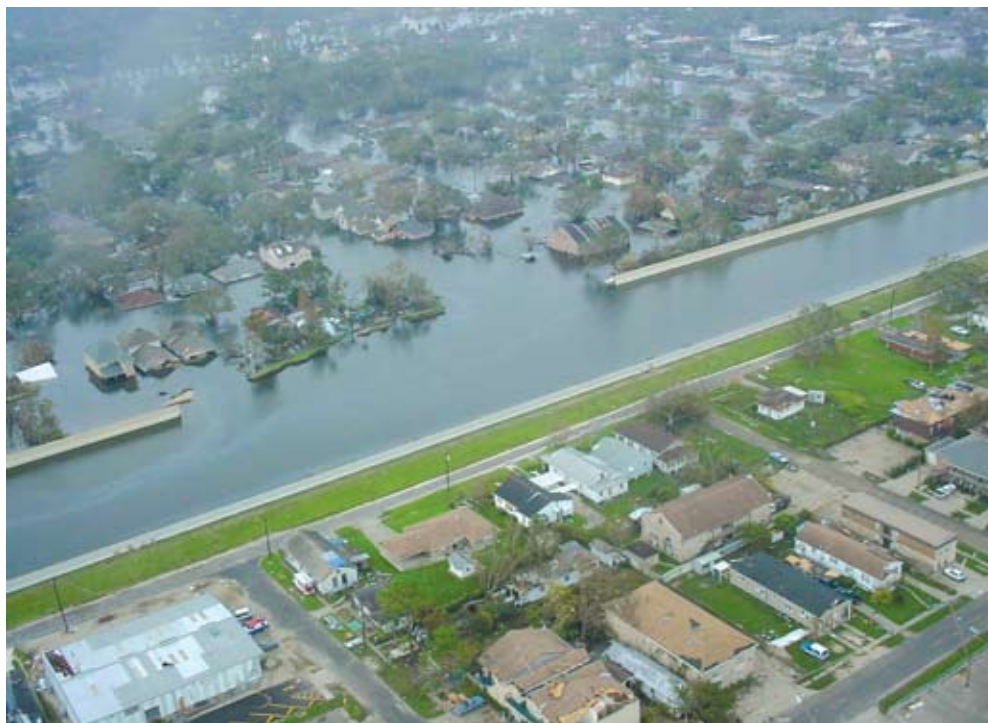
The 17th Street Canal breach began at approximately 6:30am. By 9:00am, torrents of water from Lake Pontchartrain were rushing in to flood the Lakeview neighborhood (top of photo) and, ultimately, much of midtown New Orleans and surrounding areas.

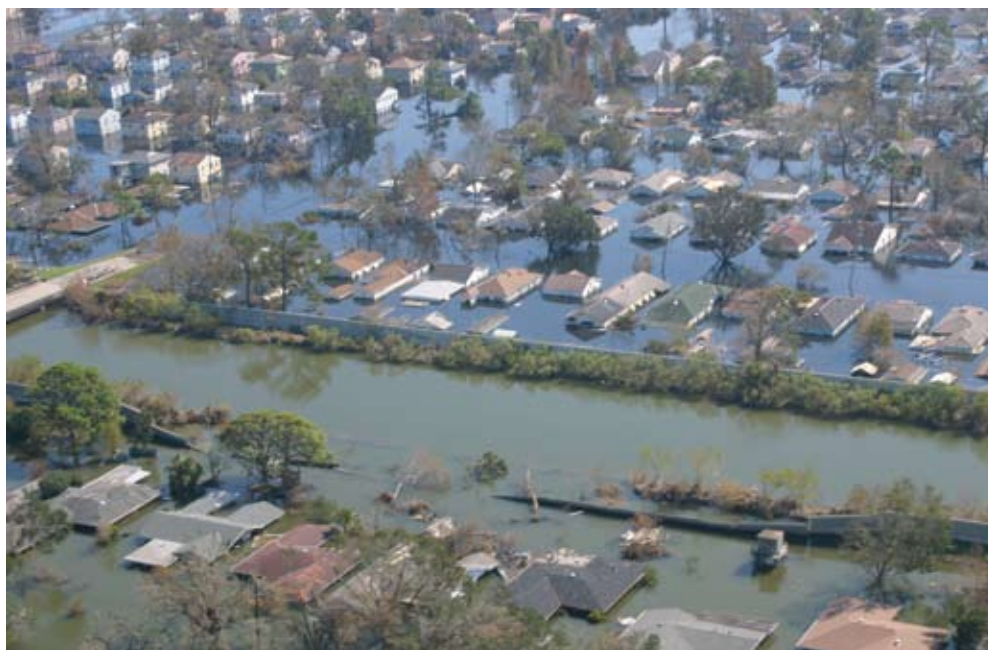
The I-wall along the west side of the London Avenue Canal failed at about 8:00am, allowing water to flood into the City Park neighborhood of New Orleans.

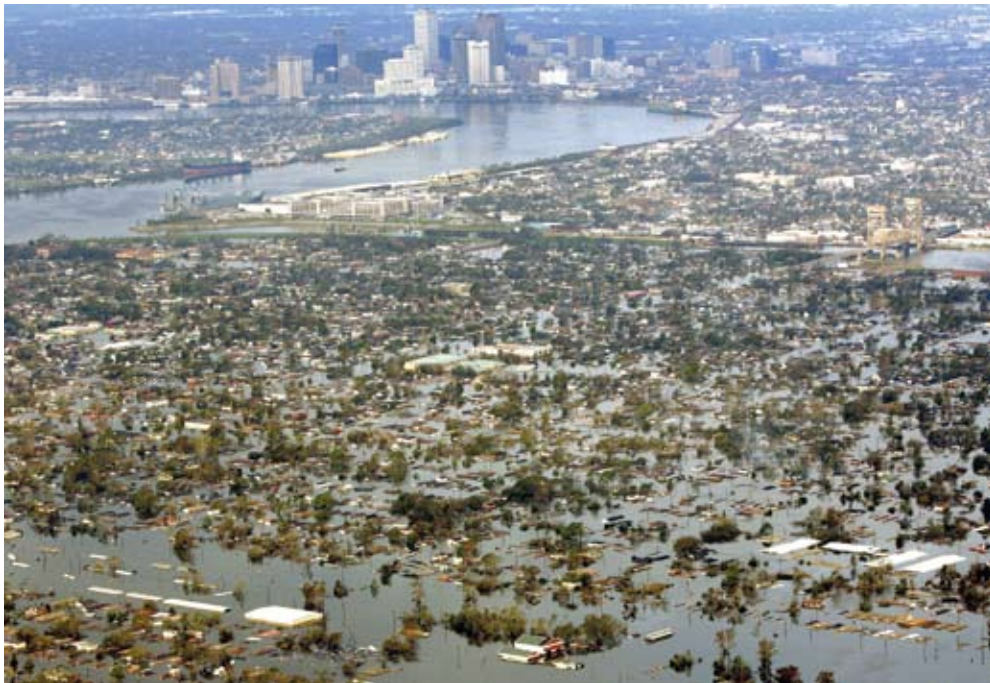
Figure 5.9 New Orleans Flooded

Overtopping and breaching at approximately 50 locations in the hurricane protection system led to destructive flooding that covered more than 80 percent of New Orleans.

By September 1, over 80 percent of the New Orleans metropolitan area was flooded as shown in *Figures 5.9 and 5.10*, with approximately two-thirds of the flooding attributed to water flowing through breaches. The remainder was attributed to overtopping and significant rain from the hurricane.

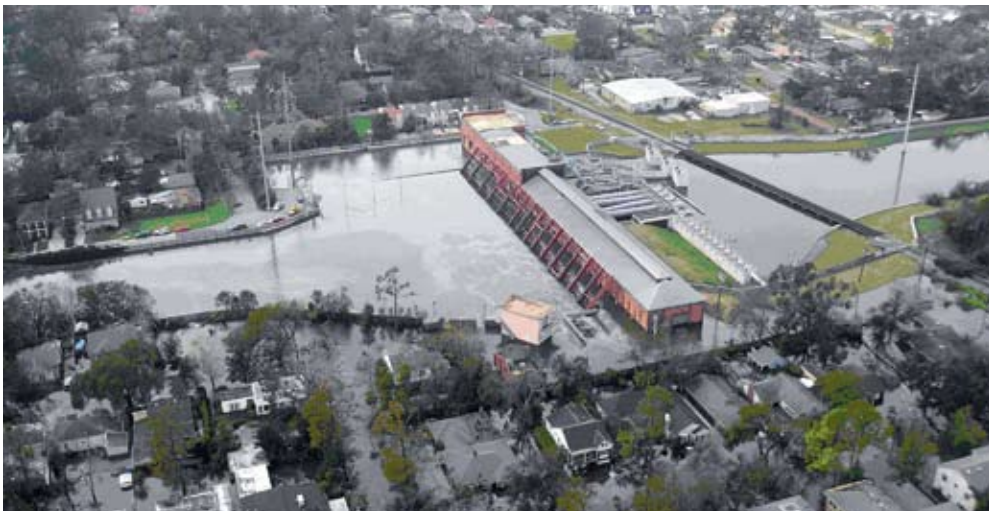
Rapid and far-reaching flooding caused by the hurricane protection system failure left most pump stations, such as Station No. 6 (on the 17th Street Canal), inoperable.

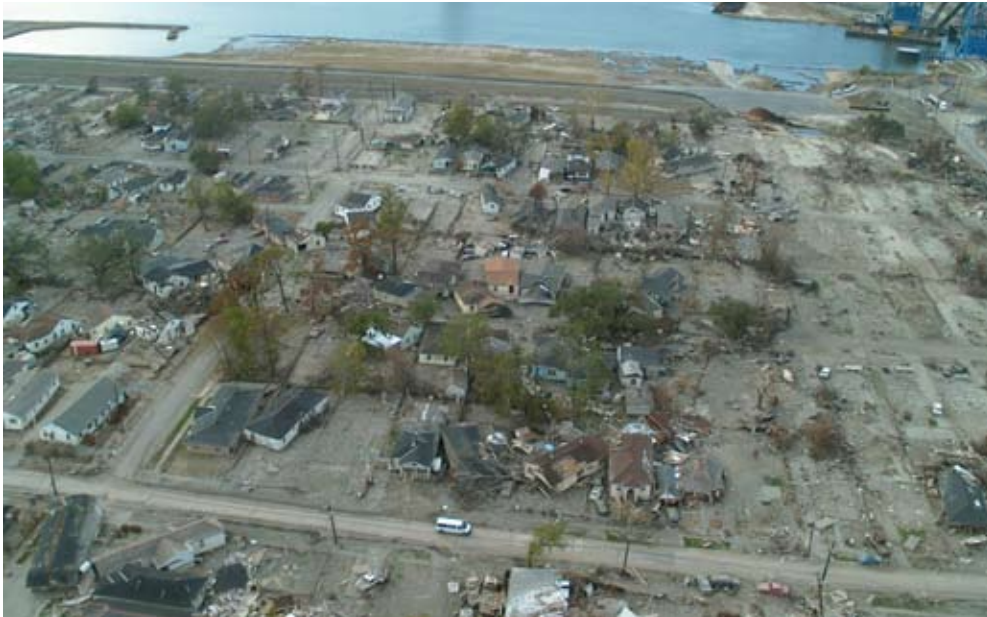
Figure 6.4 Lower Ninth Ward after Floodwaters Were Removed

The force of the torrential waters raging through Industrial Canal East Bank North Breach (upper right) knocked some houses in the Lower Ninth Ward many feet off their foundations and completely obliterated others. (This photo was taken after floodwaters had been removed.)

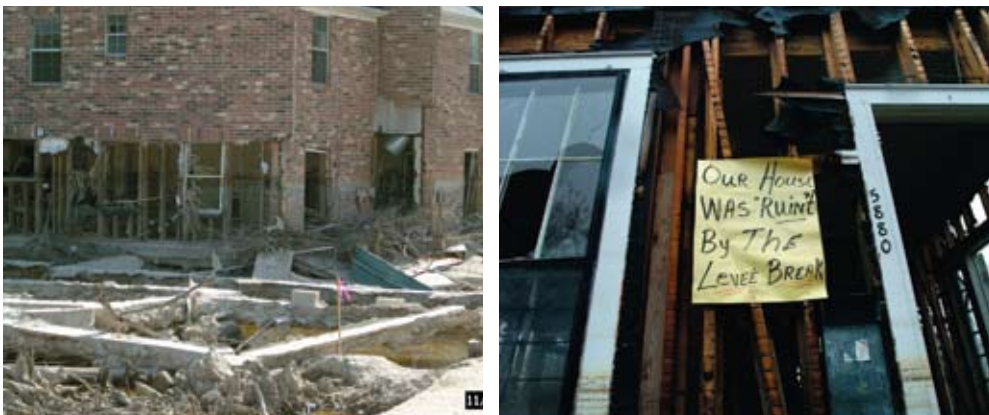
Figure 6.5 Residential Property Decimated

The IPET estimates that single-family residential property sustained over \$13.3 billion in direct losses. (These photos were taken after floodwaters had been removed.)

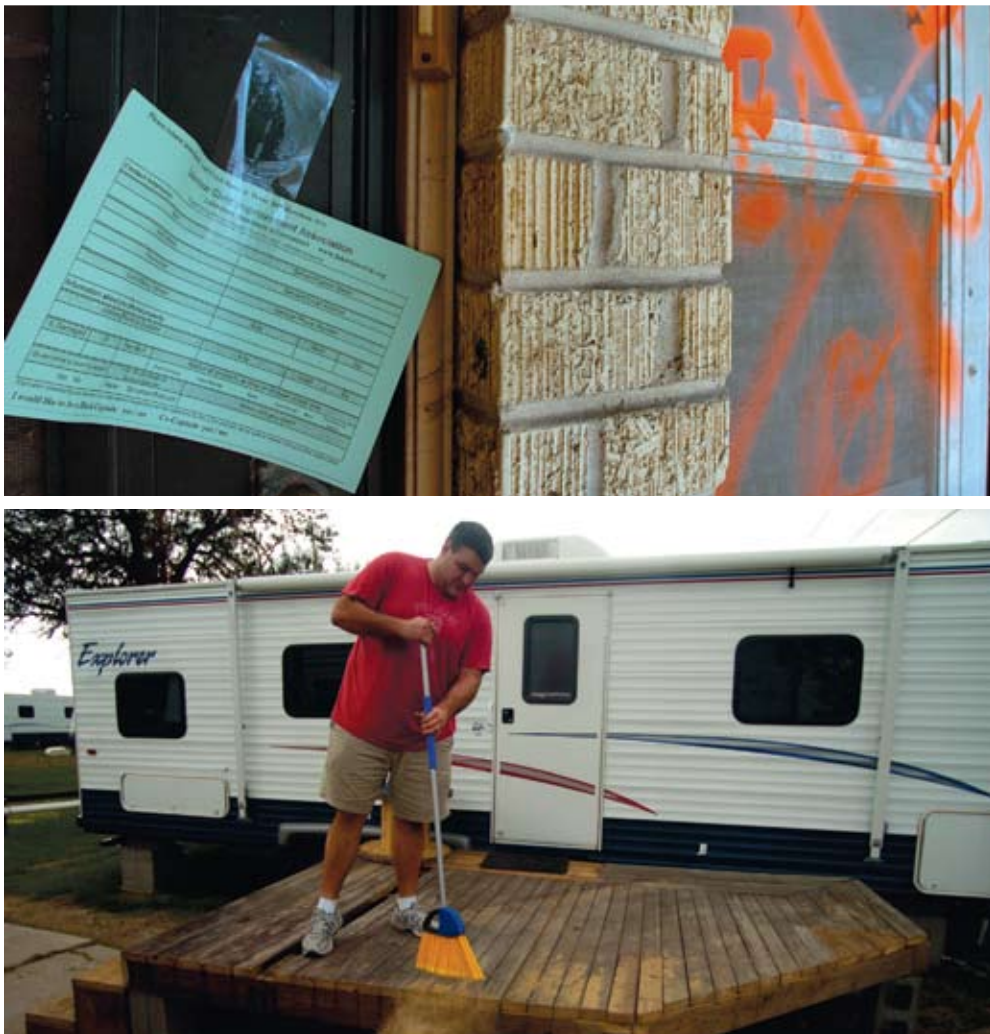
Figure 6.8 Recovery is Slow

Rebuilding efforts vary directly with the level of flooding that occurred. In Lakeview (top), where floodwaters reached 8 to 10 feet, City officials have posted survey cards on abandoned houses to determine if residents plan to return. In areas where flood levels were lower, such as portions of Chalmette (bottom), residents have started repair work while they live in Federal Emergency Management Agency (FEMA) trailers.

The significant damage to infrastructure will likely slow the recovery of population and business activities. Repair work and labor force return has occurred unevenly, but predictably, across the area. Where flood water was shallow, more recovery has proceeded. In areas where flood water was deep, little recovery or reinvestment has taken place. *Figure 6.8* illustrates the contrast in rebuilding efforts between two neighborhoods—Lakeview, which was decimated by floodwaters as high as 10 feet, and a portion of Chalmette that saw lower flood levels.

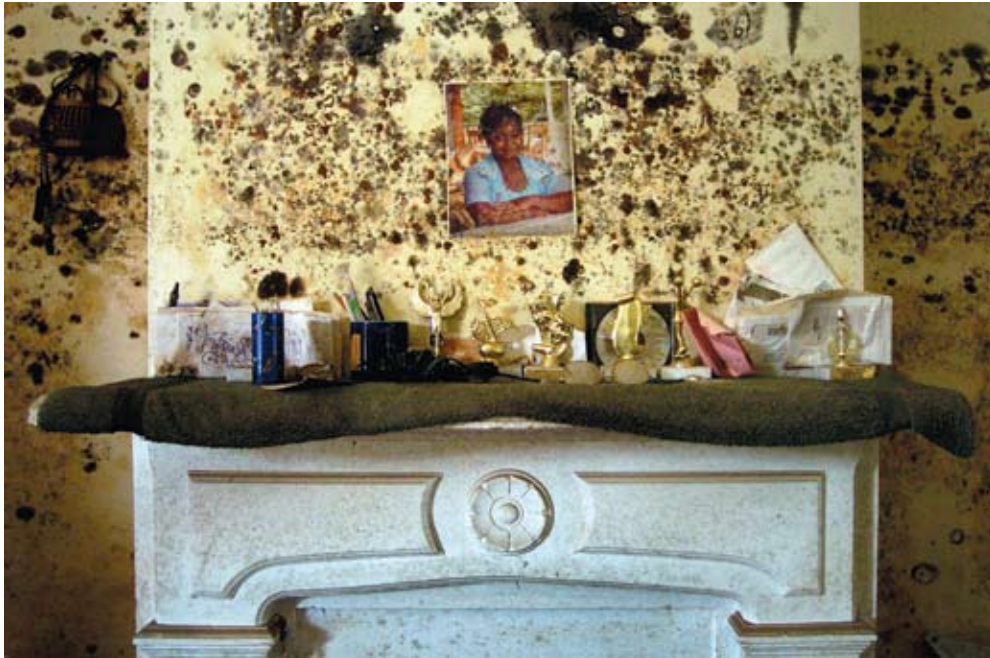
Figure 6.10 *Overrun by Mold*

Mold covering interior walls presents a significant challenge for homeowners determined to restore their houses.

Mold, as shown in [Figure 6.10](#), grew in most homes that remained flooded over several weeks, introducing a potential environmental health problem. While mold has no established exposure limits, it presents a risk of opportunistic fungal infection in immuno-compromised persons. The CDC’s measurements of airborne endotoxins that result from molds indicate that typical mold growth has reached levels associated with respiratory symptoms and skin rash.

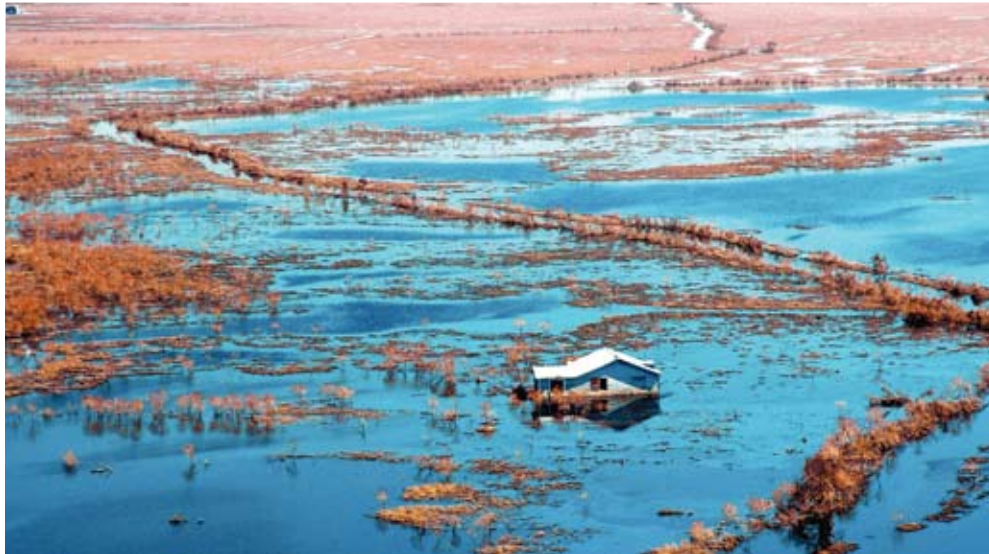
Figure 6.13 Wetlands Loss

Approximately 114 square miles of wetland loss resulted from storm surge and typical wetland loss trends, not from the hurricane protection system failure.

Although an estimated 295 square kilometers (114 square miles) of wetland loss has been attributed to Hurricane Katrina, the loss was independent of failures of the hurricane protection system. The observed loss in wetlands—and associated losses in plants and animals—is consistent with long-term wetland loss trends plus losses from the storm surge (*Figure 6.13*).

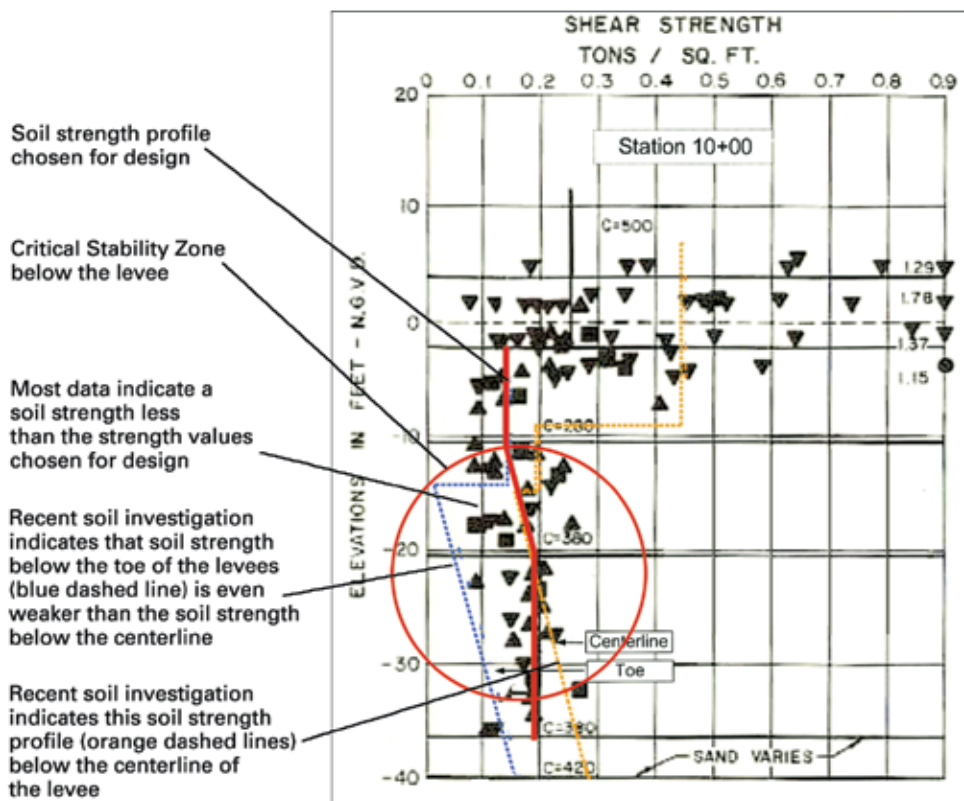
Mis-interpretation of soil data below the 17th Street Canal levee was one of three primary reasons the I-wall failed.

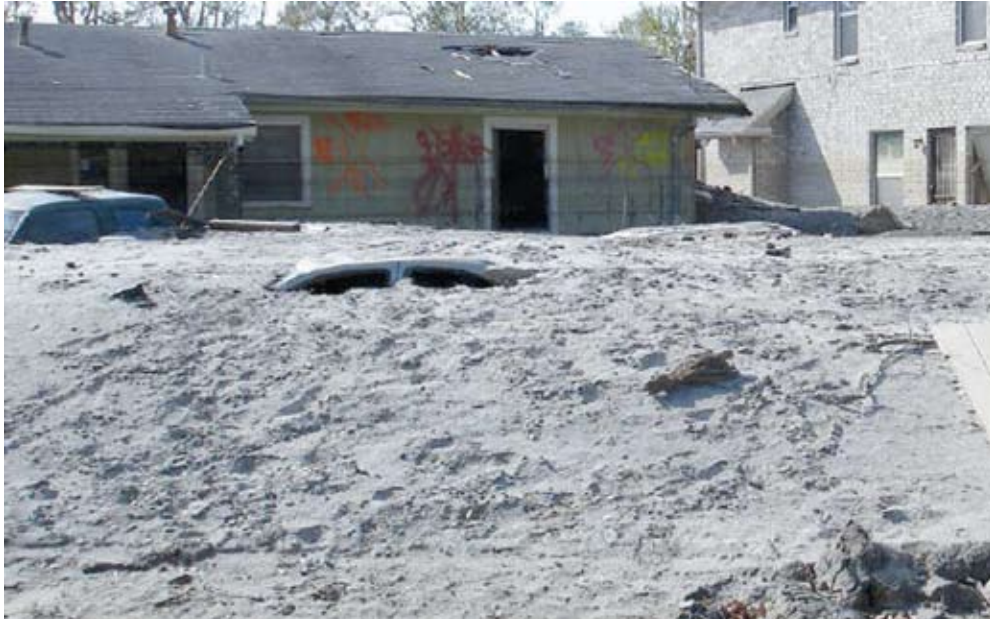
Tons of sand were washed out from beneath the levee and floodwall at the London Avenue Canal South Breach and flowed into the adjacent neighborhood. (This photo was taken after floodwaters had been removed.)

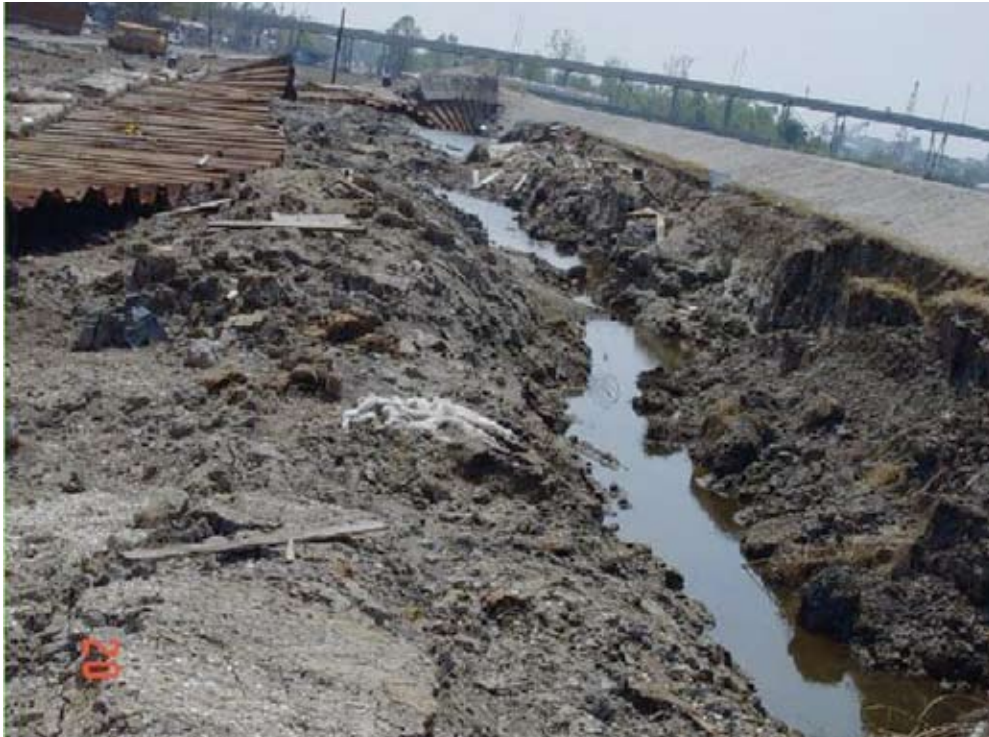
Cascading floodwaters gouged a deep trench on the land-side of the Industrial Canal. Without foundation support from the soil, the sheetpile wall (upper left) was tossed aside. (This photo was taken after floodwaters had been removed.)

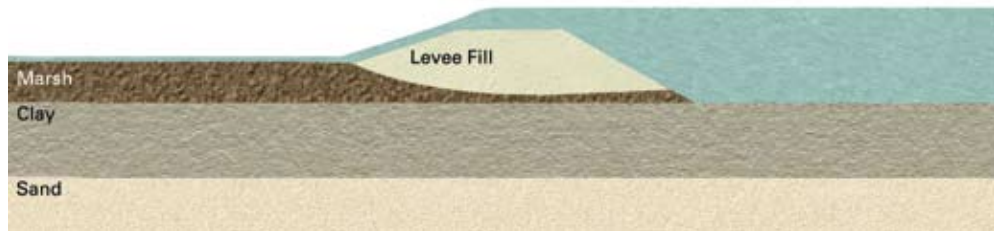
1: Floodwaters overtop the levee.

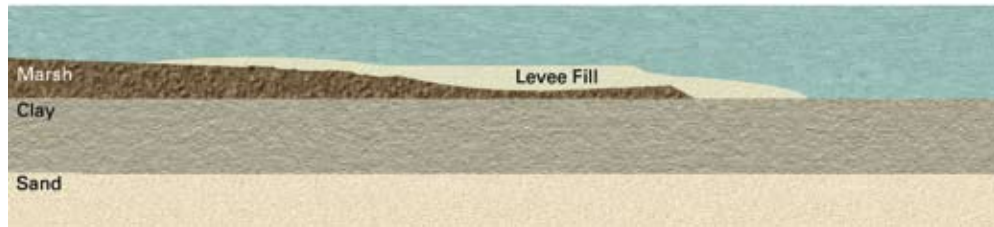
3: Some levees constructed of sand and silt washed away completely.

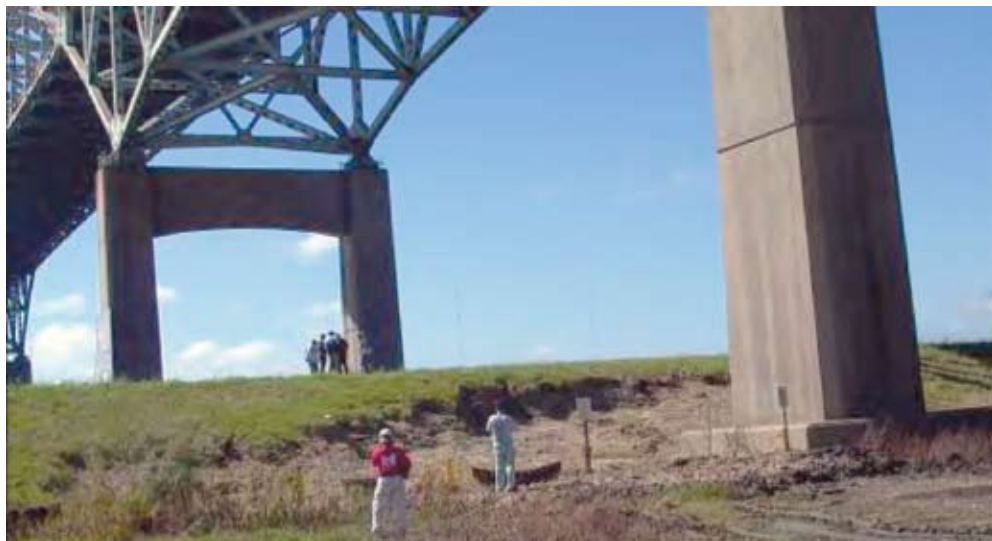
Even though this earthen levee was overtopped (as was shown in Figure 5.1), it sustained relatively minor damage. (This photo was taken after floodwaters had receded.)

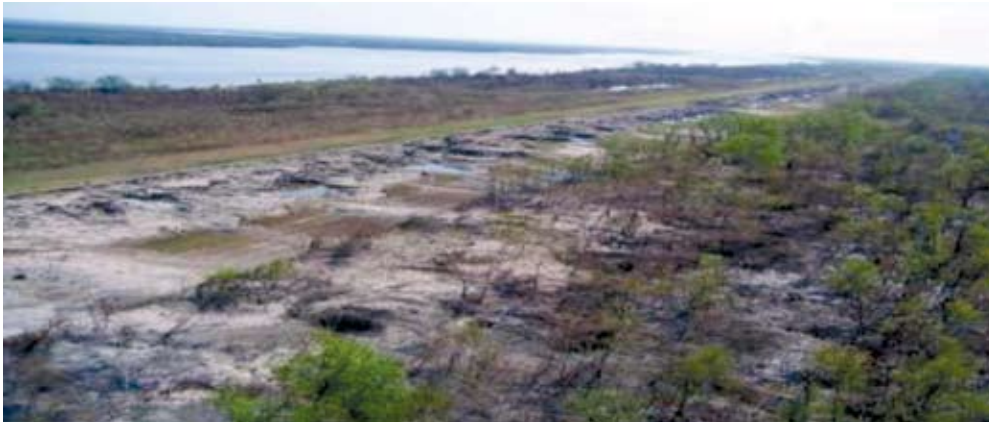
Many levees that were constructed with hydraulic fill severely eroded or washed away entirely. (This photo was taken after floodwaters had receded.)

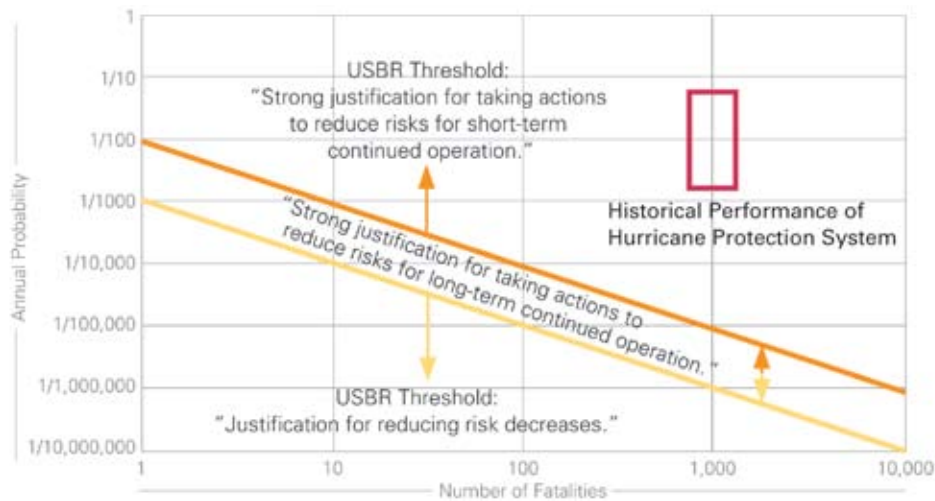
The USBR guidelines for achieving public protection in dam safety are shown in yellow. The risks posed by New Orleans's hurricane protection system (shown in red) were significantly higher than people are generally willing to accept.

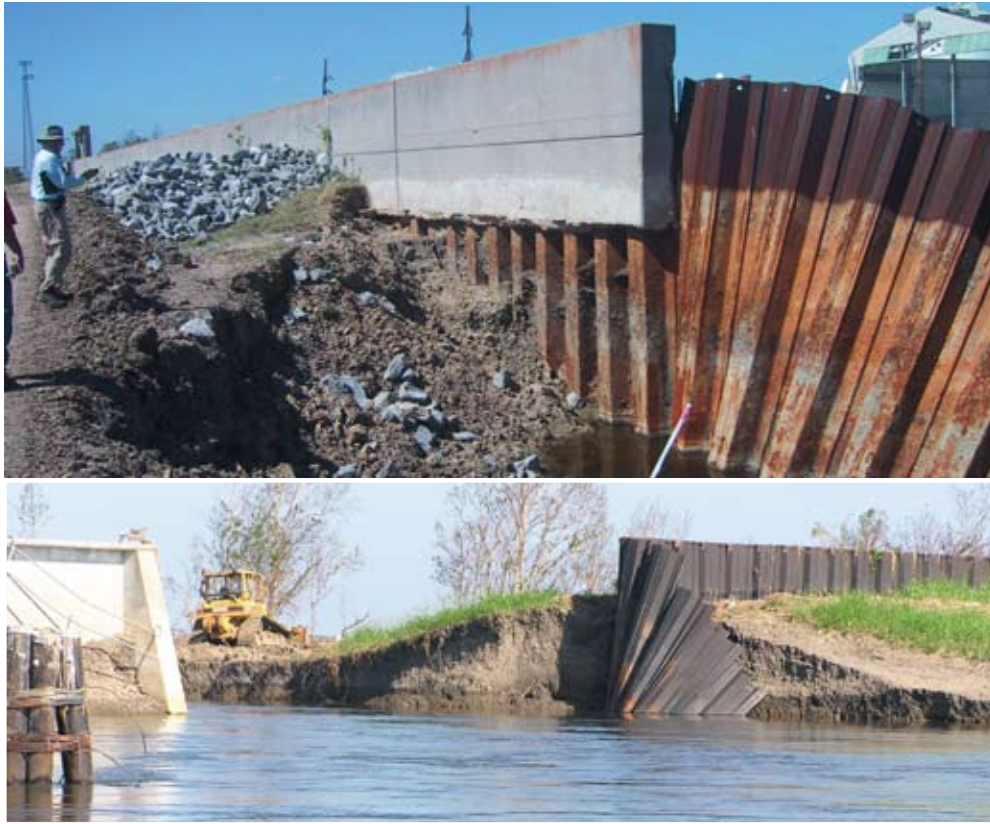
The levees and I-walls were constructed piecemeal with different top elevations and of different materials: earth, steel, and concrete. The floodwaters preferentially attacked the lower-elevation erodible earth first, causing major breaches.
